## **Final Remediation Report**

### **Wolcott Street Acid Sludge Remediation Project**

### **Former Lobell Refinery Orphan Site 57.004 Casper, Wyoming**

June 4, 2013

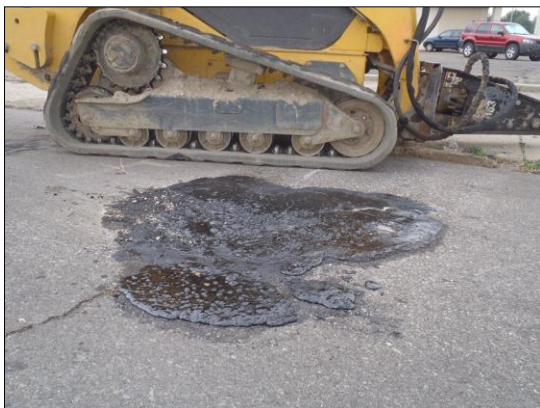
Large seep observed over Century Link line

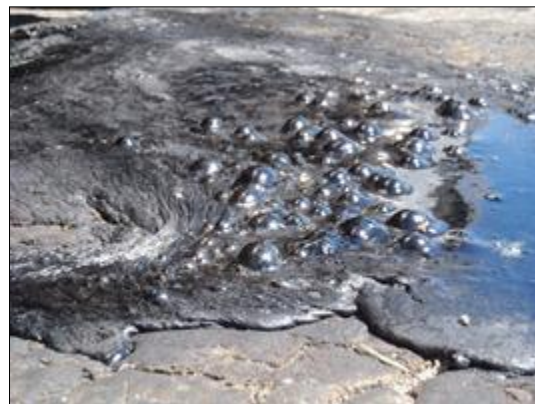
Seep observed on east side of Wolcott Street

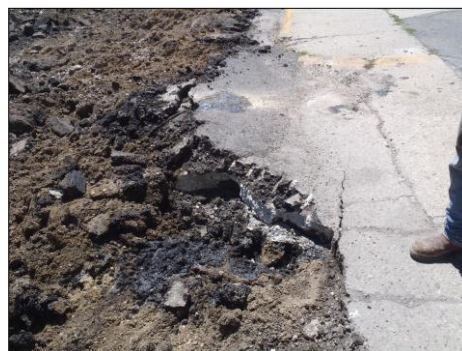
During pavement removal activities, large patches of acidic seep material were observed in several areas directly beneath the pavement. In some cases, the seep material appeared to flow into low spots in the remedial area. One significant seep, which released greater than one-half gallon of acid, emerged in a “pool” along the west boundary of the remedial area and appeared to migrate from beneath the parking area immediately south of Joshua’s Storehouse. In other portions of the remedial area, the seep material appeared to follow the buried utility lines.

Acidic seep south of Joshua’s

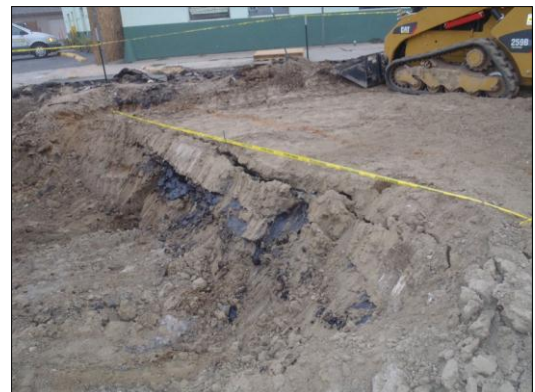
The east-west Century Link line was comprised of a four-inch diameter PVC conduit with a communications line also present along the outside of the PVC conduit. The east-west Century Link line was present approximately three feet below surface. Initially, Wyoming DEQ decided that excavation should not occur within three feet of the east-west Century Link line. However, after excavating the adjacent area north and south of the east-west Century Link line, a wooden bridge like structure was discovered just beneath the surface with abundant acidic seep material observed below the structure. Wyoming DEQ concluded that excavation should proceed from ground surface to one vertical foot above the east-west Century Link line in order to remove the highly impacted waste/soil and wooden structure. Excavation of material overlying the east-west Century Link line was completed on August 21, 2012. The excavation was overseen by Steve Hebbert, who stated there was no damage to the Century Link line during remedial excavation.

Seep material from sidewall on south side of east-west Century Link line

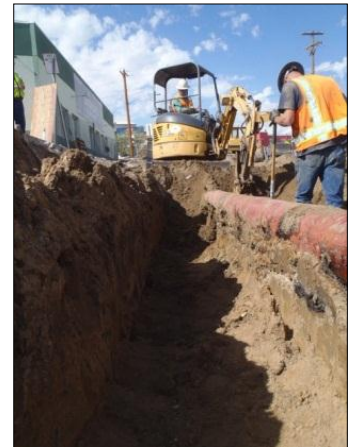
During excavation, seep waste material was observed in contact with the Source Gas main along most of the length of exposed Source Gas main located south of the east-west Century Link line. The waste material was observed primarily along the bottom and in some portions along the sides and top of the Source Gas main. There was limited seep material observed to be in contact the Source Gas main north of the east-west Century Link line.

Seep material on and below Source Gas main

It was necessary to undermine the Source Gas main for the entire exposed length in order to provide access for Source Gas to remove waste residue from the surface of the pipe and install a protective wrapping. The photograph at right shows seep material adhering to and below the Source Gas main during excavation of the acidic waste/soil above and adjacent to the pipe line.

During excavation, wooden cribbing was installed to temporarily support the Source Gas main until backfill could be placed around the pipe. The Source Gas main was not exposed within three horizontal feet of the east-west Century Link line in accordance with direction from Wyoming DEQ. It is unknown if the six feet of Source Gas main adjacent to the east-west Century Link line has been impacted by waste or during installation of the east-west Century Link line. Source Gas confirmed there was no damage to the Source Gas main or service line during remedial activities.

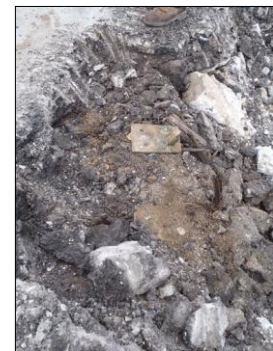
1. During pavement removal activities on August 1, 2012, railroad ties from an old railroad siding were discovered paralleling the south edge of the remedial area. The northern rail of railroad track was observed in the south sidewall of the remedial area. The railroad siding was depicted on historical Sanborn® Maps from the early 1900's. Acidic waste/soil was observed beneath the railroad siding in the eastern portion of the southern excavation wall. After consulting with the City of Casper City Engineer, Mr. Andrew Beamer, the Wyoming DEQ elected to leave the railroad siding and the acidic waste/soil in place and no further excavation beyond the south boundary of the remedial area was performed.

Exposed rail, 12 in. depth

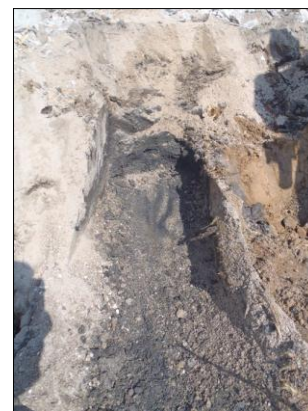
4. On August 22, 2012, a wooden conveyance (raceway) containing oily sediment was discovered protruding from the west sidewall of the remedial area near the southeast corner of Joshua's Storehouse. The conveyance was assumed to be a remnant of the former Lobell Refinery. The contents of the conveyance were collected and stored in a 55-gallon drum and the wooden structure was excavated for disposal. Samples were collected and delivered to Pace Analytical Services for analyses to determine if the oily material was a characteristic hazardous waste. Analytical results indicated the material was not a characteristic hazardous waste. The laboratory report is provided in Appendix V. The oily sediment was transported to the Casper Regional Landfill for disposal as petroleum contaminated soil (PCS).

Wooden Raceway

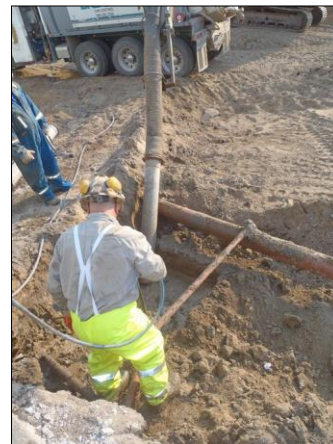
Hydrovacating hole for  
waterline installation

Wyoming DEQ decided to replace a portion of the water service line to Joshua's Storehouse. Because part of the water service line was located in an area where waste was to be left in place, Wyoming DEQ and the City of Casper required the replacement water service line to be installed inside a plastic conduit where the new service line entered Joshua's Storehouse.

The replacement water service line extended from the southeast corner of the building to the south side of the east-west Century Link line where waste was left in place. Wyoming DEQ required that excavation not be conducted within one vertical foot above and three horizontal feet on each side of the east-west Century Link line. Therefore, Badger Daylighting was contracted to hydrovac a hole for the water line approximately three feet below the east-west Century Link line. Huber Plumbing was contracted to install the sleeved water service line from the existing service line to Joshua's Storehouse utilizing the hole completed by Badger Daylighting. The hydrovacating and installation of the new portion of the water service line were completed on August 30, 2012. The installation of the replacement water service line was approved by City of Casper inspector Mr. Jim Bowden on August 30, 2012.

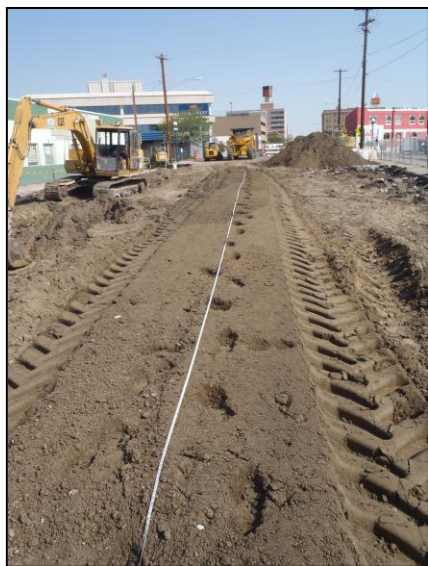
On-Site Treatment Area

The on-site treatment process consisted of the addition of a measured volume of cement kiln dust (CKD) to the excavated acidic waste/soil placed in the treatment area, followed by mixing with a CAT RM-500 Rotary Mixer (Reclaimer) to ensure the acidic soil/waste was sufficiently blended with the pH neutralizing agent.

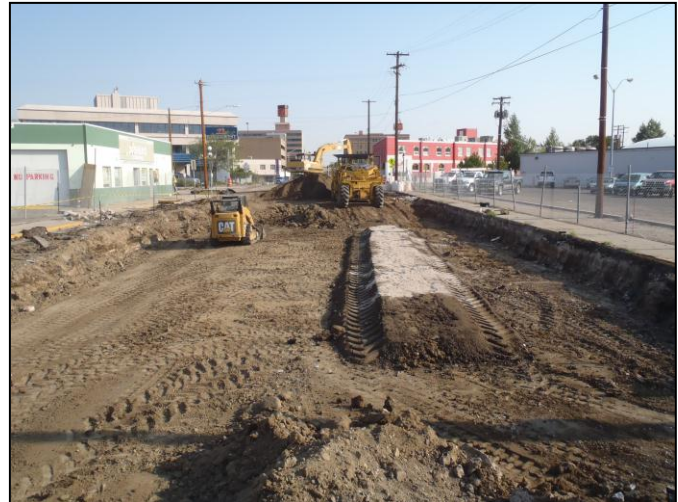
The appropriate volume of CKD was evenly applied by hand to the surface of the acidic waste/soil in the treatment area. Over the course of the project, an average of approximately 0.6% of CKD by volume was required to adequately neutralize the waste/soil.

CKD application to on-site treatment area

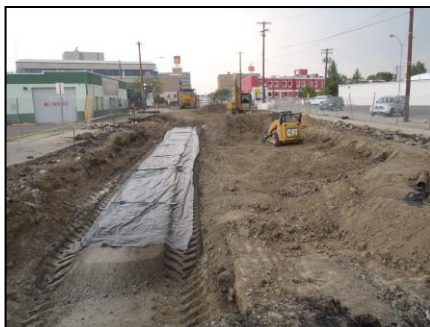
Covered treatment area, end of day

- For fugitive dust resulting from project construction activities, dust generation was controlled by watering utilizing a garden hose and sprayer as needed during excavation activities.
- Water application was also used to remove material from the pavement at the truck loading area to minimize fugitive dust and off-site tracking.
- Waste/soil loaded in the treatment zone was covered with a tarp when airborne dust was observed and at the end of each work day.
- Loaded trucks leaving the Site were covered to prevent dust generation.

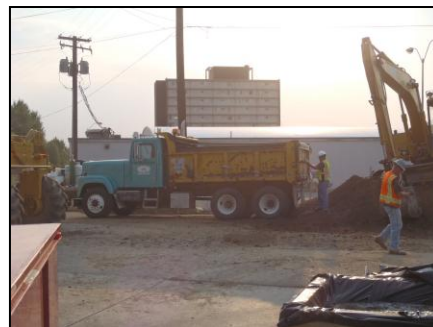
Loaded truck covered for transport  
to Casper Landfill
